Pavement Management Plan

**Indian Wells Country Club Community-FAMD #1
Indian Wells, CA**

**January 2021
Job No. 20033**

Subject: Pavement Management Plan
Indian Wells CC / FAMD #1

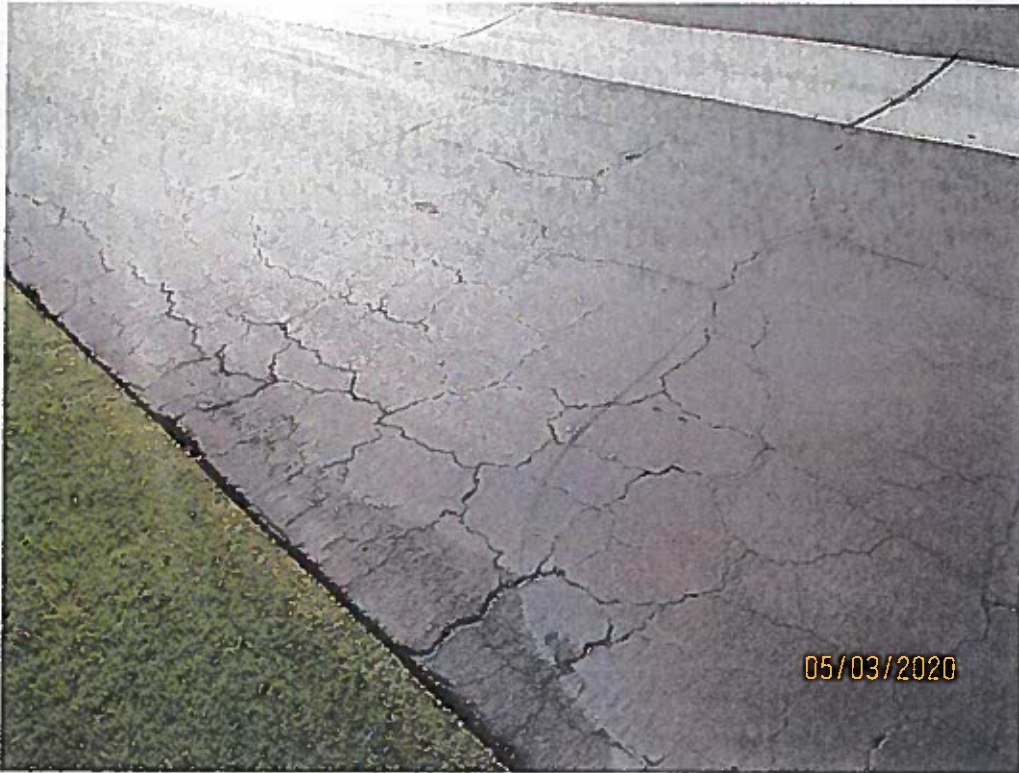
PHOTO 1

Priority 1, 2021 – Streets scheduled in this Priority are generally in poor condition. Continuous slight to severe block (photo 1) and intermittent to continuous slight to severe alligator fatigue cracking (photo 2) are evident throughout these streets. We are recommending isolated AC / PCC repairs, milling the previous overlay & fabric interlayer from the street and installing a new AC overlay with fabric interlayer, as well as full-reconstruction on the streets outlined in Priority One.

This photo represents intermittent slight to moderate block cracking. This is also an example of a previously sealed smooth surface.

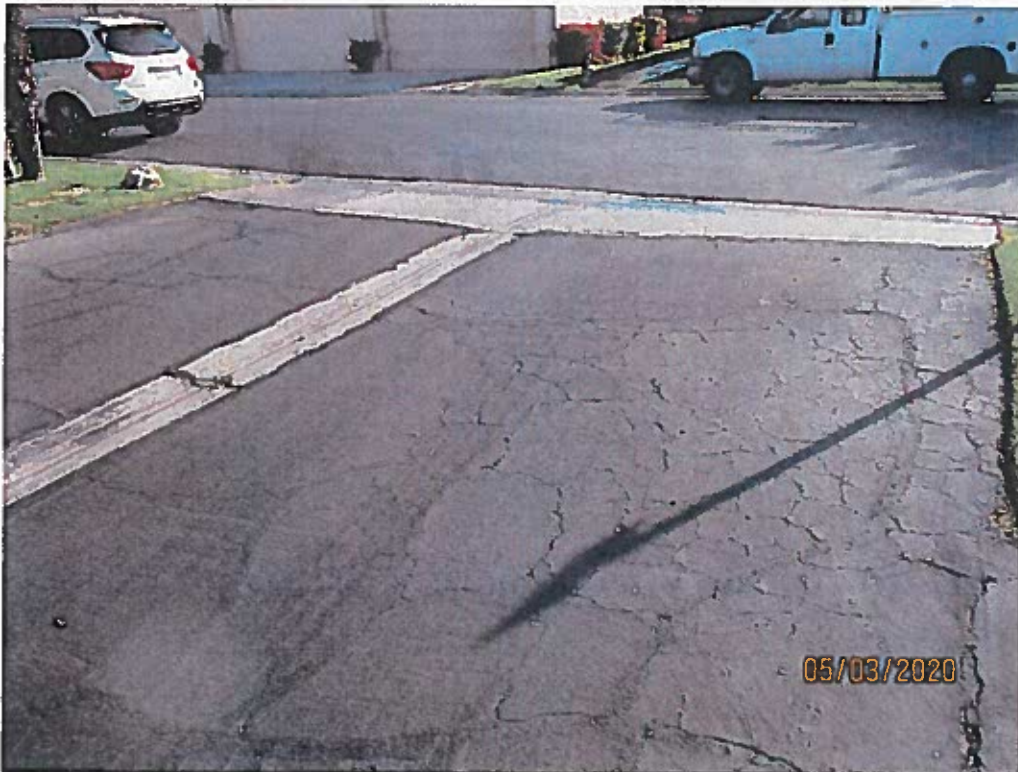
PHOTO 2

This photo represents intermittent to continuous moderate alligator cracking.

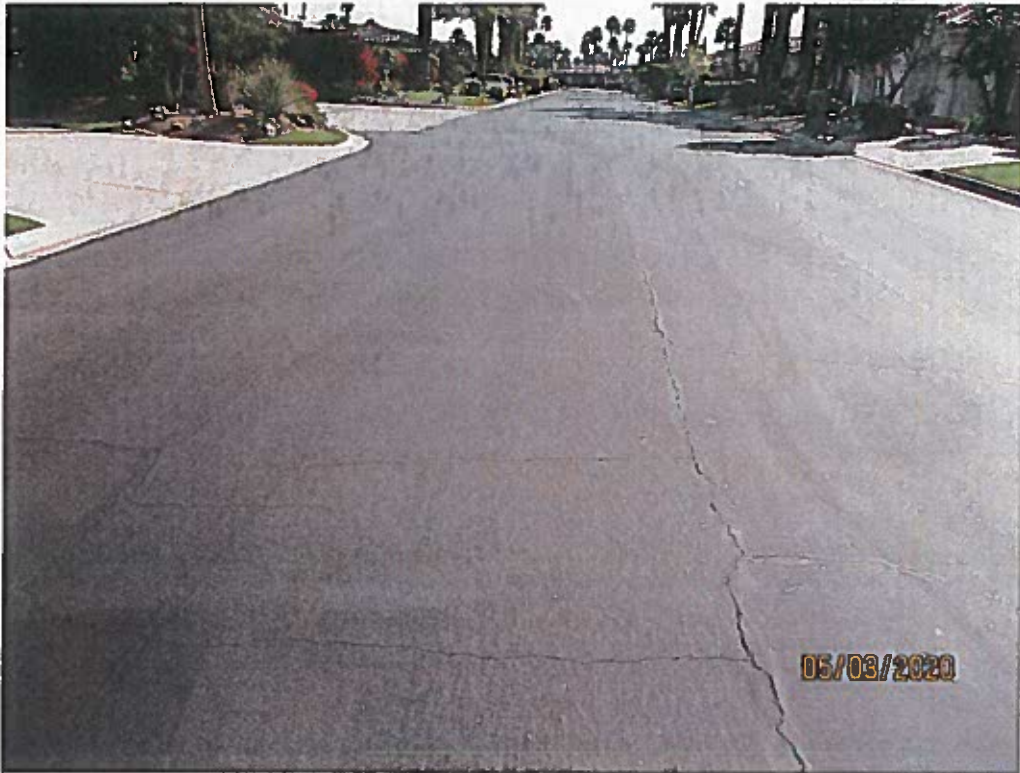
PHOTO 3

Priority 2, 2022 – Streets scheduled in this Priority are generally in poor condition, but are slightly better than those identified in Priority 1. Continuous moderate to severe block (photos 3 and 4) and intermittent slight-to-moderate alligator fatigue cracking (photo 5) are evident throughout these streets. We are recommending isolated AC repairs, milling the previous overlay & fabric interlayer from the street and installing a new AC overlay with fabric interlayer on streets outlined in Priority Two.

Continuous moderate block cracking is depicted in this photo. This street was recently sealed and is in fair to good condition.

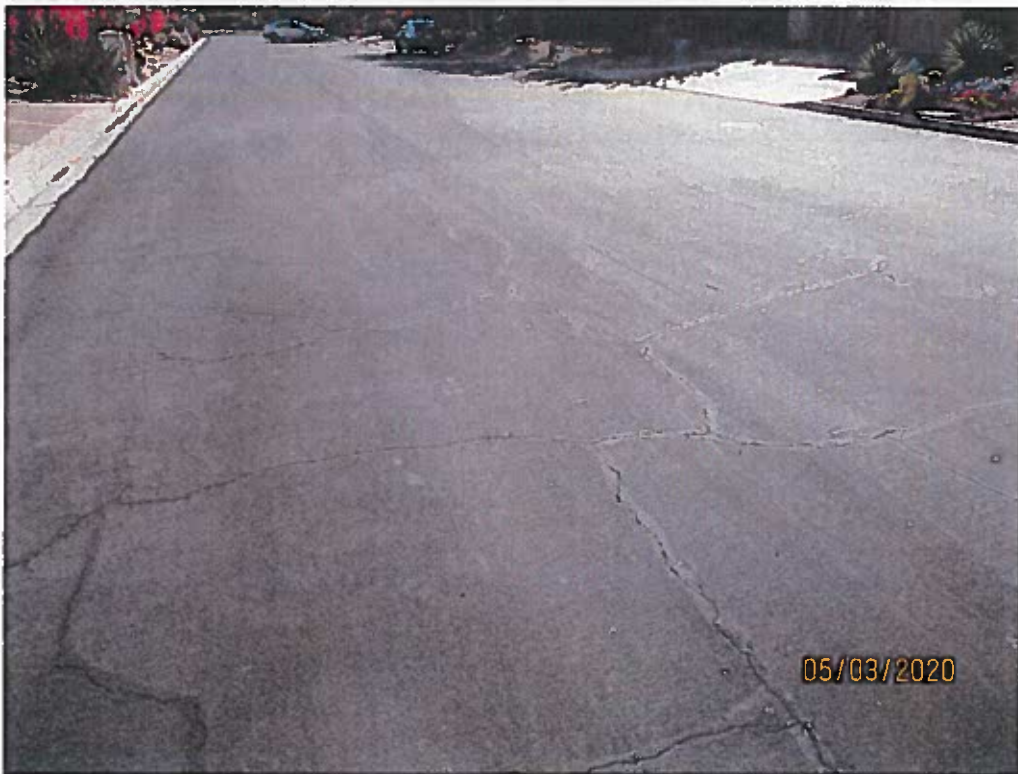
PHOTO 4

Another example of moderate to severe block cracking.

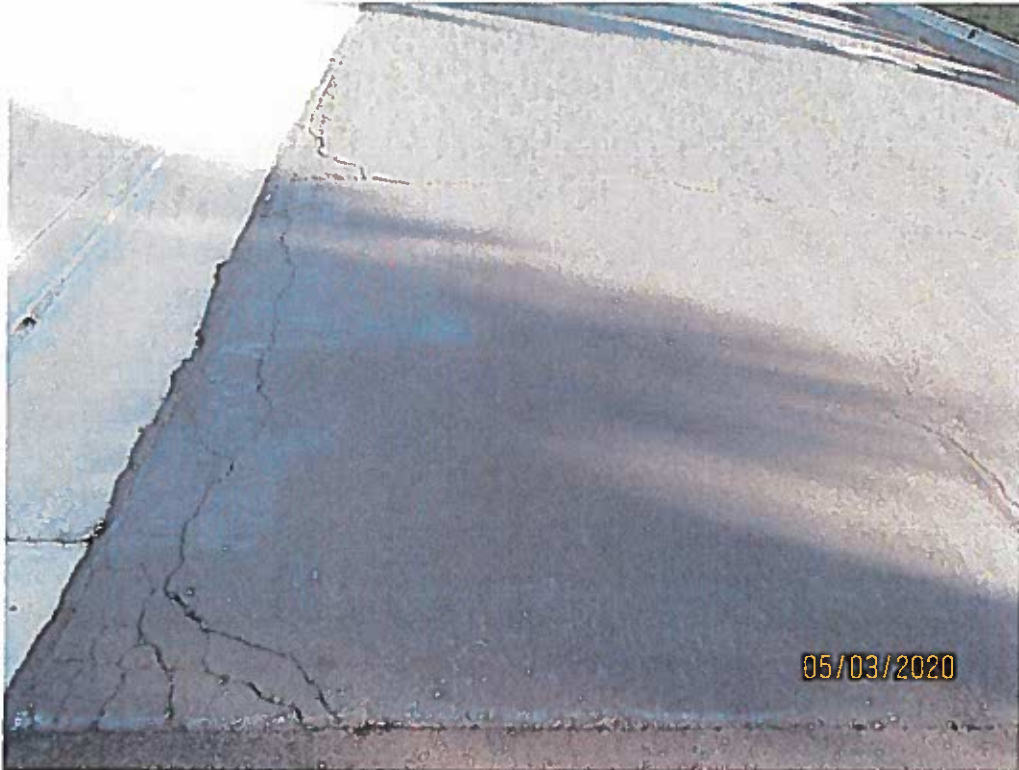
PHOTO 5

This is an example of isolated moderate alligator fatigue cracking.

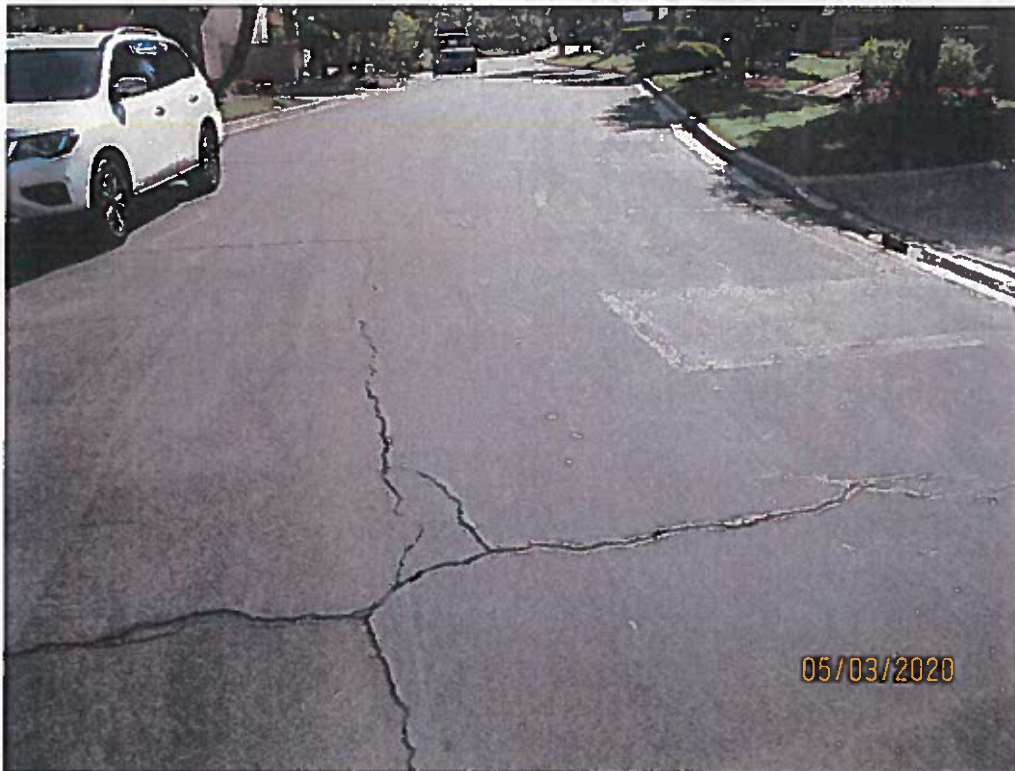
PHOTO 6

Priority 3, 2023 – Streets scheduled in this Priority are generally in poor-to-fair condition, yet are in slightly better condition than the streets identified in Priority 1 & 2. However, there were some major defects noted. Continuous slight to severe block (photo 6) and typical isolated-to-intermittent PCC repairs needed (photo 7) are evident throughout these streets. We are recommending isolated AC / PCC repairs, milling the previous overlay & fabric interlayer from the street and installing a new AC overlay with fabric interlayer, and surface seal coat, on streets outlined in Priority Three.

Continuous moderate to severe block cracking is depicted in this photo.

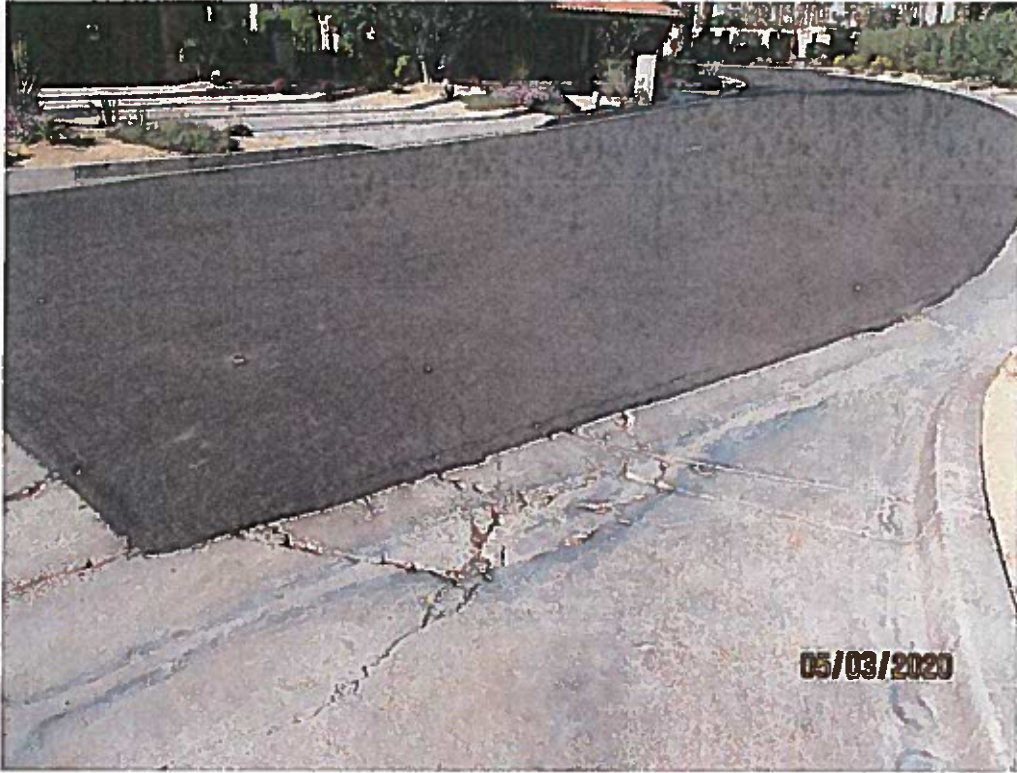
PHOTO 7
Typical PCC repair needed is depicted in this photo.

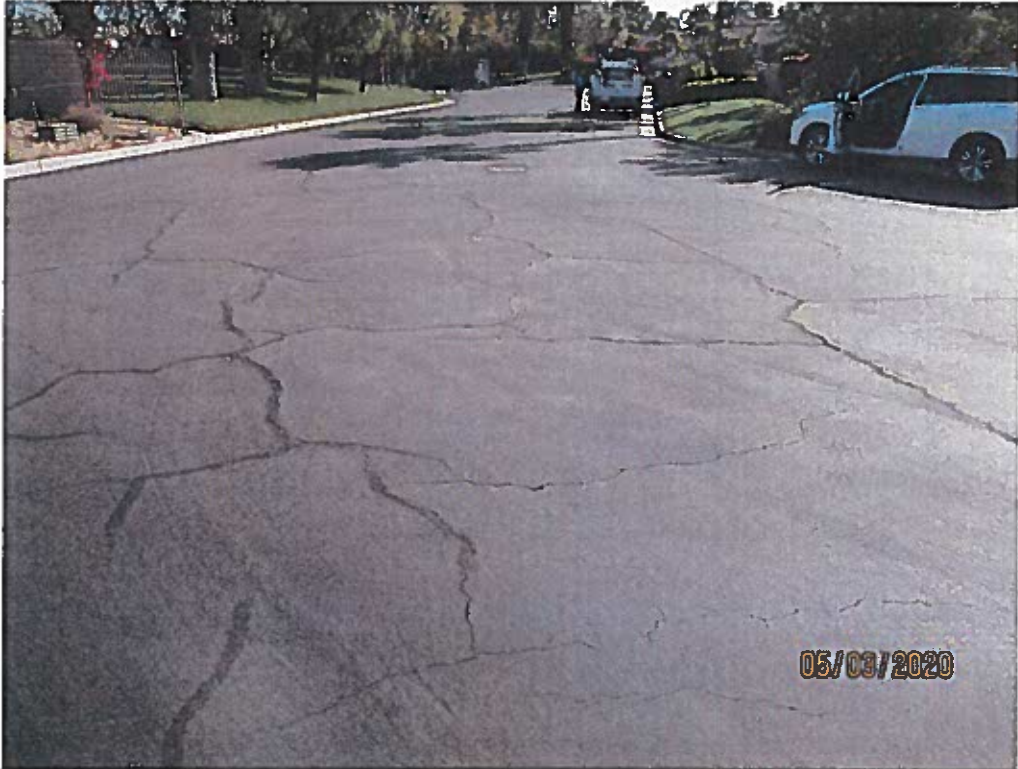
Priority 4, 2024 – Streets scheduled in this Priority are generally poor-to-fair, and are in similar condition to the streets identified in Priority 3. Continuous moderate to severe block (photo 8) and intermittent-to-continuous moderate-to-severe block cracking (photo 9) are evident throughout these streets. We are recommending isolated AC repairs, AC overlay with fabric interlayer, and surface seal coat, as outlined in Priority Four.

PHOTO 8
Continuous slight to severe block cracking is depicted in this photo.

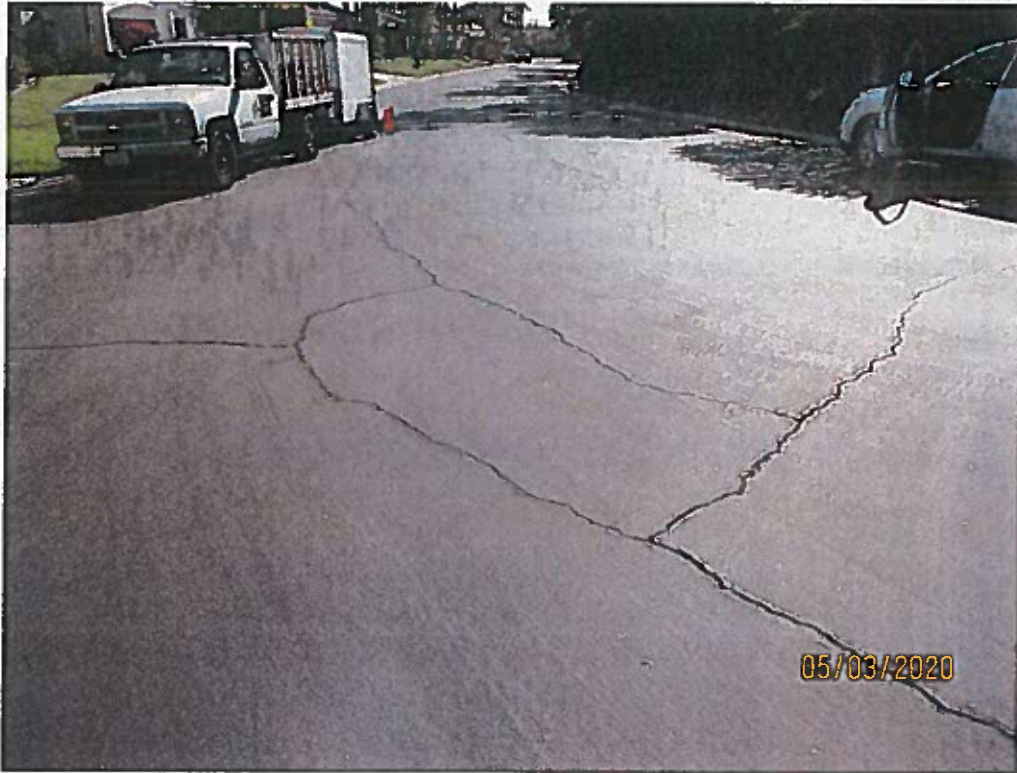
PHOTO 9

This photo is another example of continuous severe block cracking.

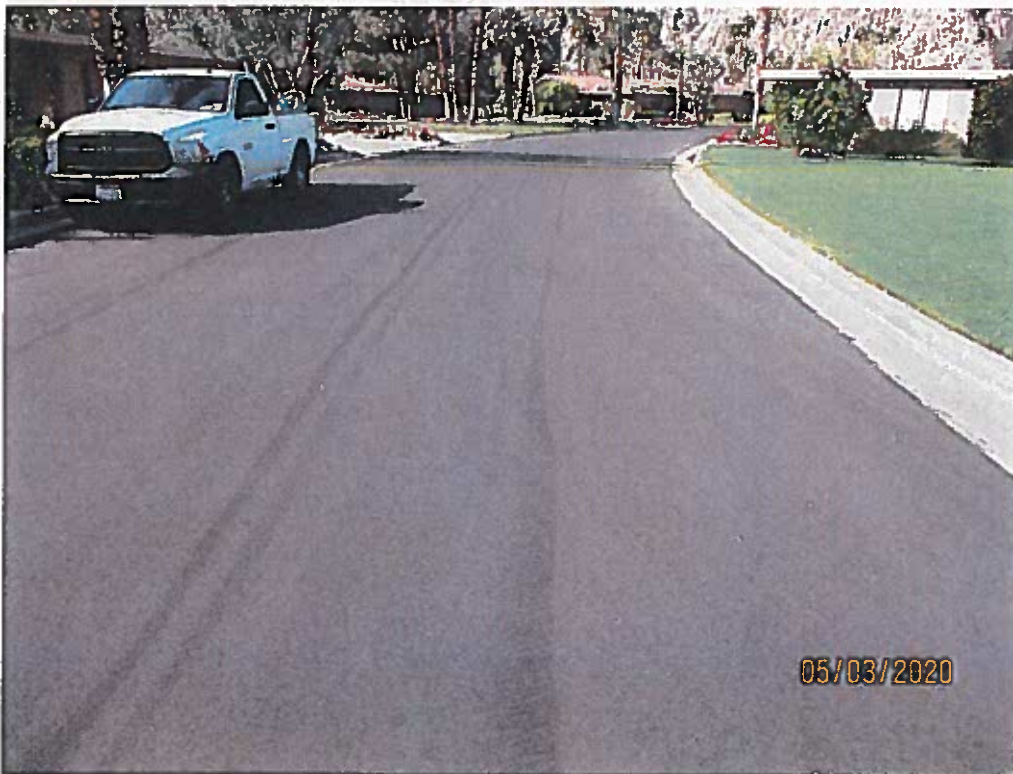
PHOTO 10

streets will most likely not need any major repairs (photo 10) and simply require surface seal coat in order to protect Indian Wells' investment in pavements, which had been completed in the previous Priorities.

A street which requires surface seal coat is depicted in this photo. This street was recently reconstructed with new asphalt.
